INDOOR AIR QUALITY ASSESSMENT

**Department of Mental Health
13 Prospect Street
Greenfield, MA**

Prepared by:
Massachusetts Department of Public Health
Bureau of Environmental Health
Indoor Air Quality Program
July 2017

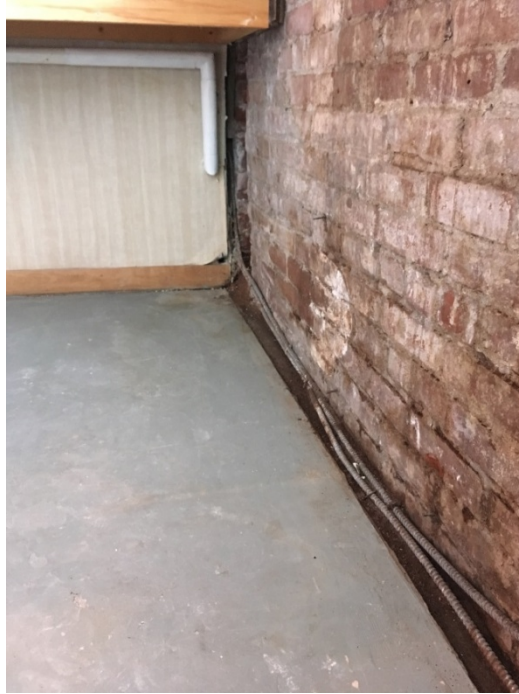
Picture 1

As stated, concerns about mold in the basement prompted this assessment. Basement offices are constructed of gypsum wallboard (GW) covered in vinyl wallpaper. All GW installed along the exterior wall of the building was removed, exposing the foundation wall (Picture 1). GW installed below grade along the foundation has a tendency to become moistened by water penetrating through the wall. With the removal of this GW, the basement was found free of mold/musty odors.

The base of the brick foundation wall was found moistened, likely from water penetration from pooling water against the building due to a lack of a gutter/downspout system along the roof.

Foundation wall with removed GW

5. Render window-mounted ACs as watertight as feasible to prevent water penetration during driving rain.
6. Consider installing a gutter/downspout system to the roof edge.

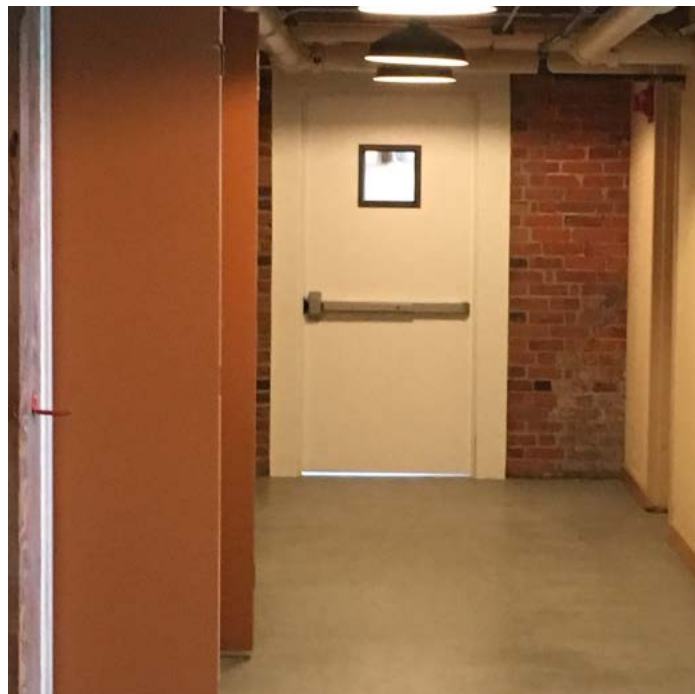
Picture 2

Both doors accessing the basement have spaces that allow for basement air to enter the stairwells/foyer (Picture 2). These breaches can provide pathways for drafts, moisture and odors into other parts of the building.

Space under basement access door

2. Install door sweeps and weather-stripping on stairwell and lobby access doors.
3. Remove water-damaged wallpaper around windows.
4. Consider replacing the carpets in offices on the first floor.

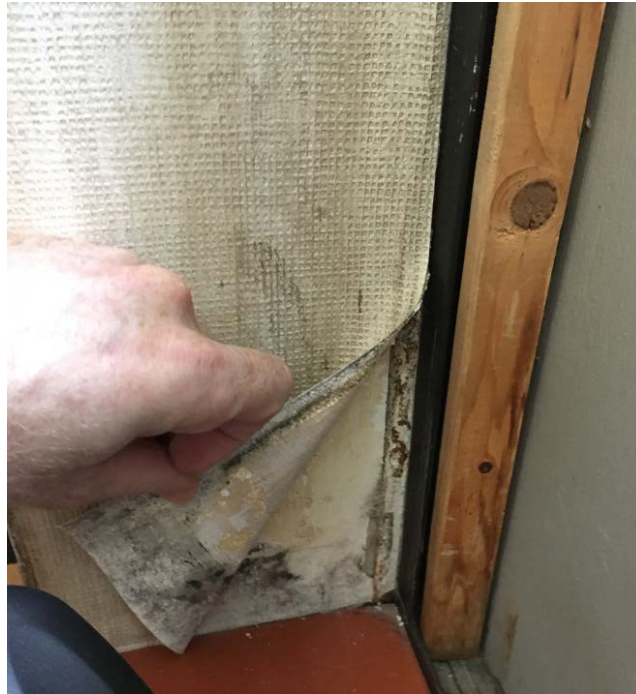
Picture 3

Windowsills were examined in offices. Vinyl wallpaper had become detached from the wall along windows with ACs, indicating water penetration, likely during wind-driven rain events. In some cases, the wallpaper paste had become colonized with mold (Picture 3).

Water-damaged wallpaper

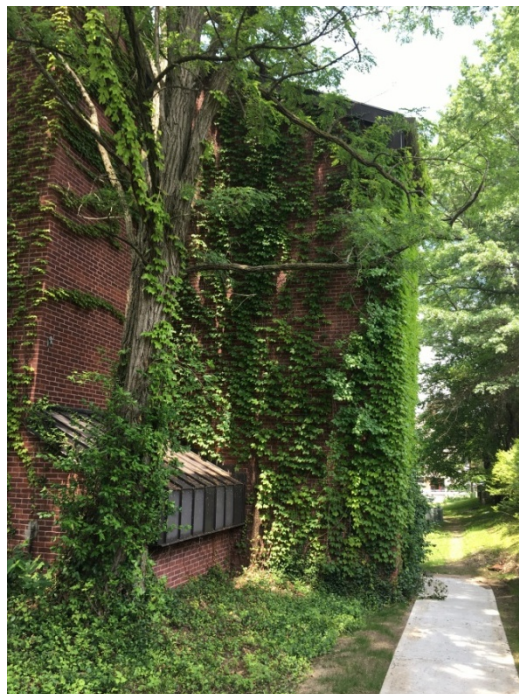
Picture 4

Ivy was observed on the building's exterior (Picture 4). Roots growing into the brick mortar can create fissures, which can cause crumbing and deterioration of the building exterior due to freezing and thawing of water trapped in these spaces. Over time, water can enter the building through damage to the exterior wall.

Ivy on exterior of building

7. Remove ivy from exterior brick walls.
8. Reduce/eliminate odorous products in office space.
9. For buildings in New England, periods of low relative humidity during the winter are often unavoidable. Therefore, scrupulous cleaning practices should be adopted to minimize common indoor air contaminants whose irritant effects can be enhanced when the relative humidity is low.
